Manhole Inspection Summary

Manhole # S33GG2015MH

Location Address: **100 CEDARCROFT RD** Cross Street: **BELLONA AVE**

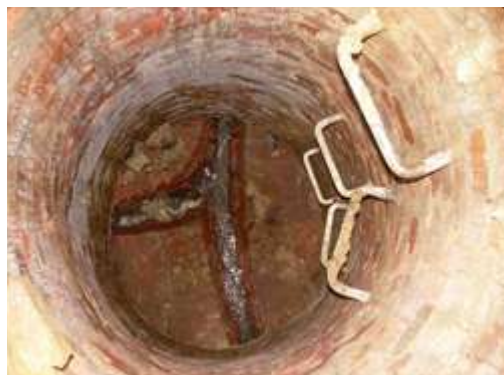
Top View

Evidence of surcharge - Bench debris.

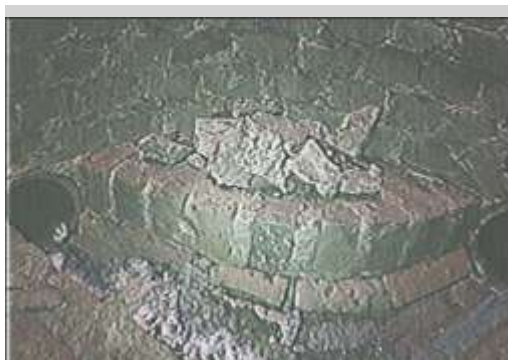
Defect

Barrel deterioration and infiltration.
Channel deterioration.

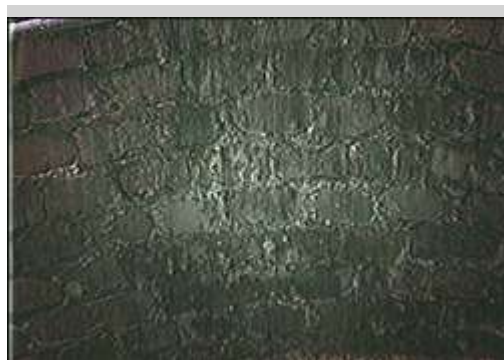
Defect

Barrel deterioration and infiltration.

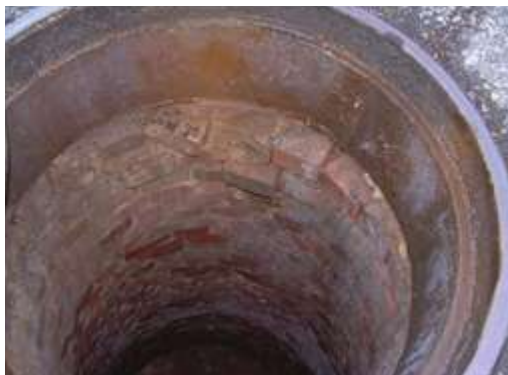
Defect

Frame leaks. Frame offset. Adjustment
deterioration, loose brick, and infiltration.
Corbel and Barrel infiltration - other side.

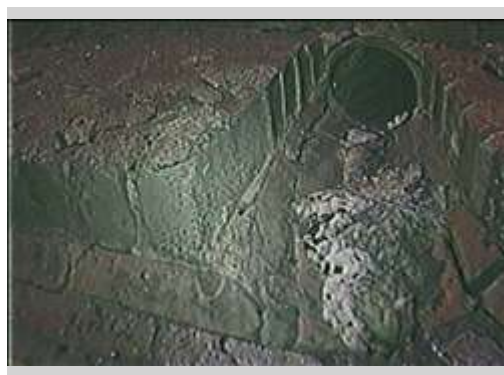
Defect

Channel deterioration and debris.

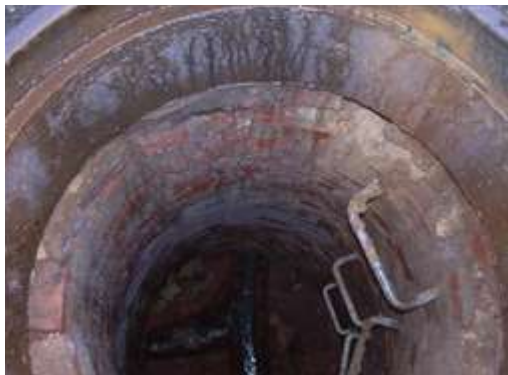
Defect

Frame leaks. Frame offset. Adjustment deterioration and infiltration. Corbel and Barrel infiltration.

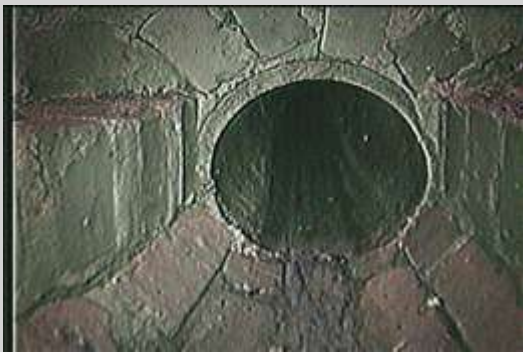
8 in. Circular Gravity Sewer Pipe Out @ 12 O'Clock

Infiltration: **Evidence** Pipe Seal Cond: **Cracked**

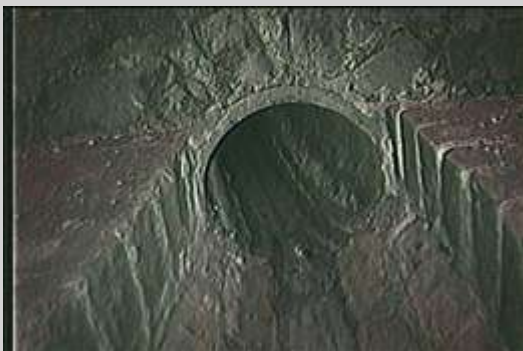
8 in. Circular Gravity Sewer Pipe In @ 5 O'Clock

Deposits: ☐ None ☐ Mud ☐ Sludge ☐ **Debris** ☒ **Grease**

Infiltration: **None** Pipe Seal Cond: **Cracked**

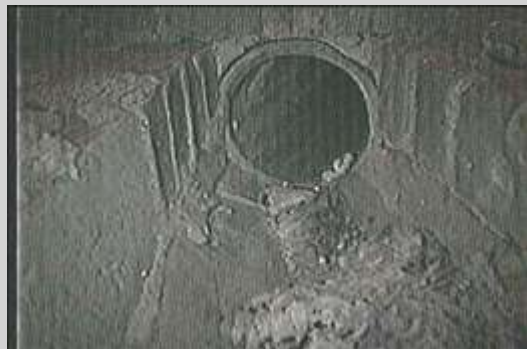
Pipe In @ 9 O'Clock

Deposits: ☐ None ☐ Mud ☐ Sludge ☒ **Debris** ☐ Grease

Infiltration: **Evidence**
